-MAINTENANCE PAVEMENTS: RESULTS OF FIELD STUDIES ON THE PERFORMANCE REQUIREMENTS AND CAPABILITIES OF CONVENTIONAL PAVEMENT SYSTEMS

April 1976

Interim Report

7. Author(s)	8. Performing Organization Report No.
Michael I. Darter and Ernest J. Barenberg

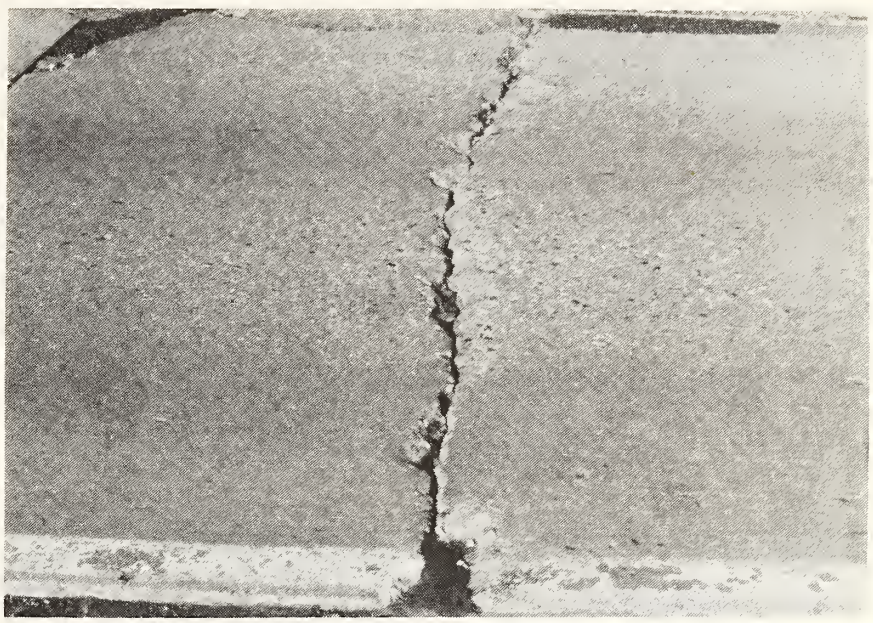
Figure 3.4. Illustration of transverse cracking rated "severe" on a jointed concrete pavement (JCP-1-IL).

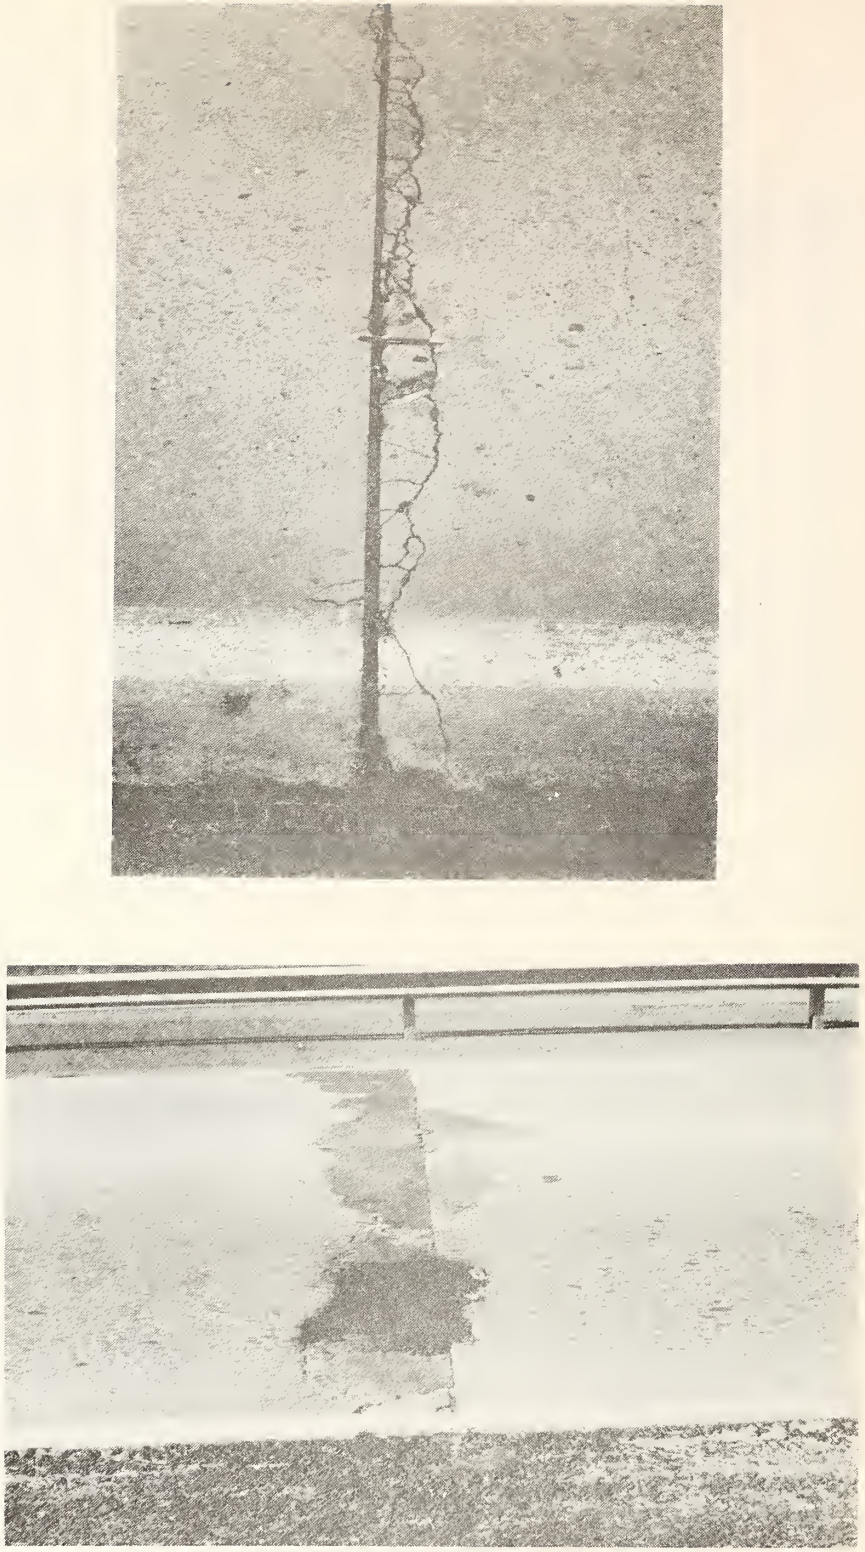
Figure 3.7. Illustration of joint spall rated as "severe" on a jointed reinforced concrete pavement (JRCP-16-NY).

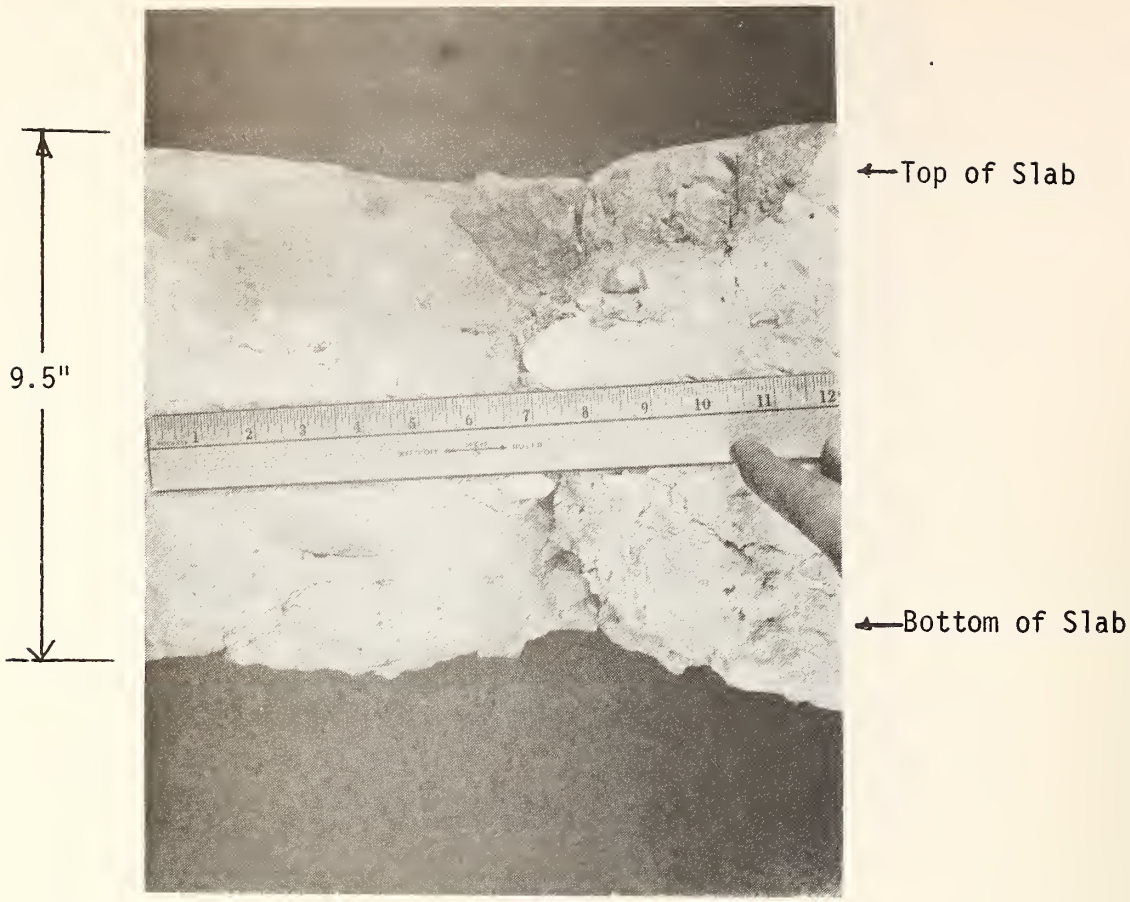
Figure 3.8. Joint cut from 17-year concrete pavement (JRCP-7-IL) showing serious concrete deterioration.

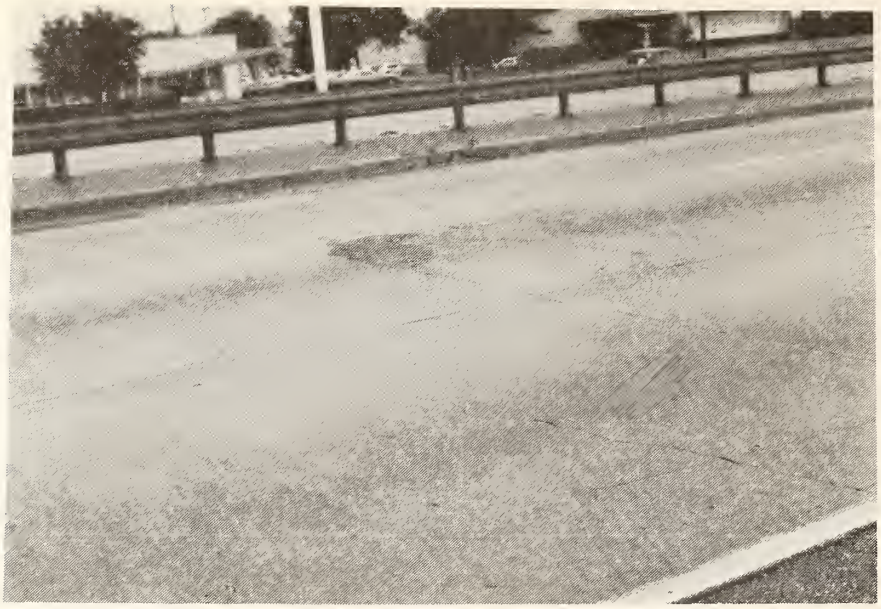
Figure 3.14. Illustration of a localized failure on a continuously reinforced concrete pavement (CRCP-8, Dallas, Texas).

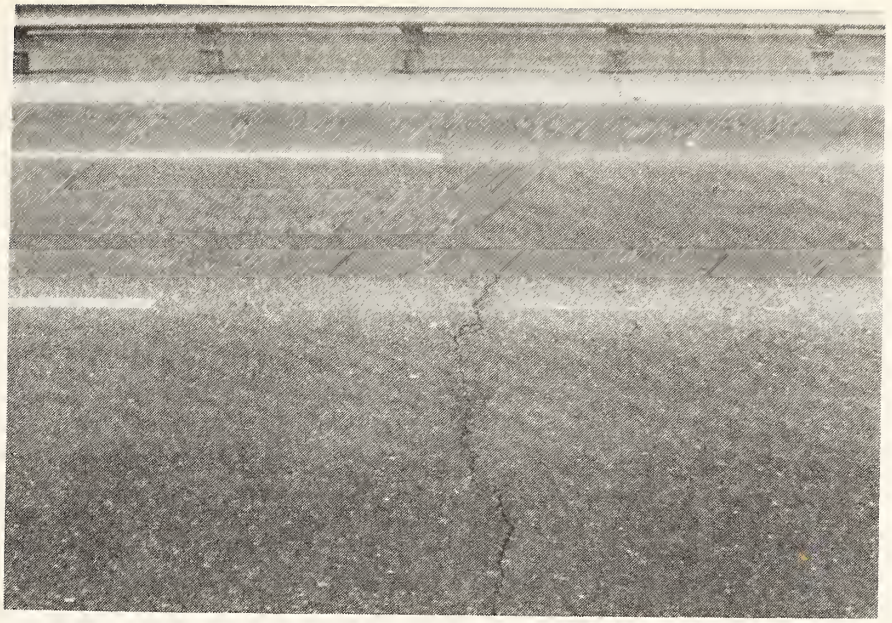
Figure 3.24 Illustration of a tight transverse reflection crack of a composite pavement (COMP-4, Toronto).

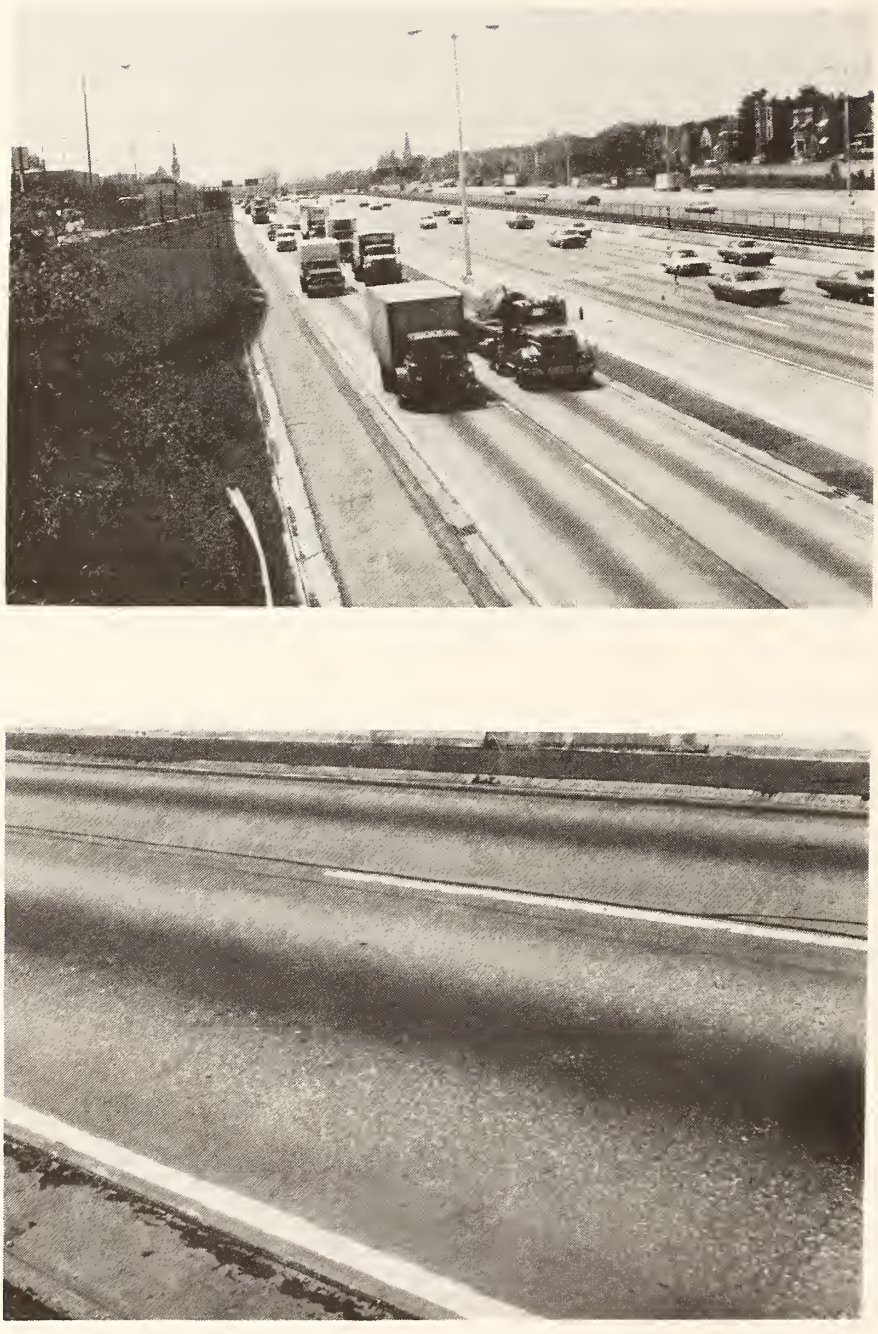
Figure 6.8. Maintenance-free CRCP (Dan Ryan Expressway, Chicago, Illinois), with a traffic of 4 x 10^6 18-kip ESAL/year (lane, 10 inches thick constructed 1971).
